**DANA POINT GENERAL PLAN
COASTAL EROSION TECHNICAL REPORT**

**DANA POINT GENERAL PLAN ,
COASTAL EROSION TECHNICAL REPORT**

PN 89312-2

Subject: City of Dana Point General Plan, Coastal Erosion Technical Report.

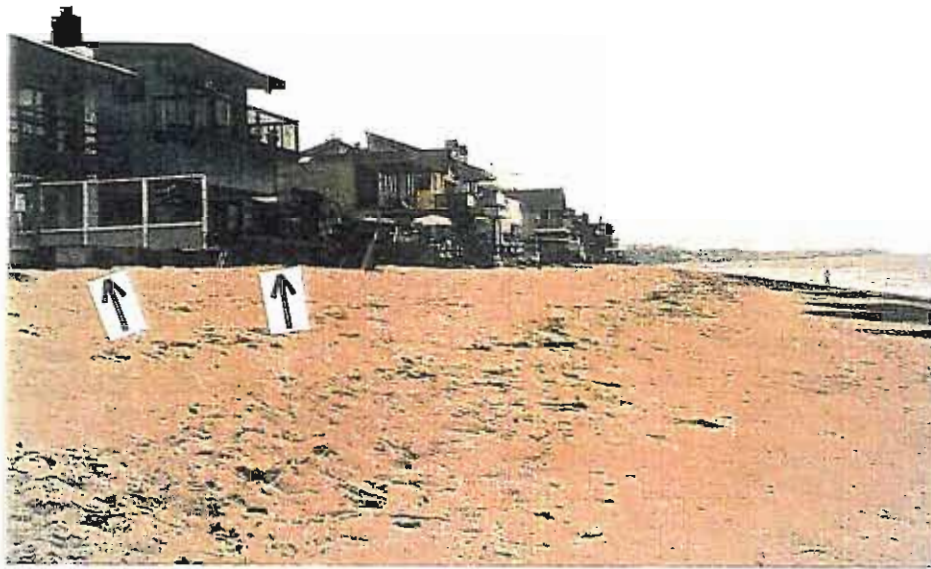
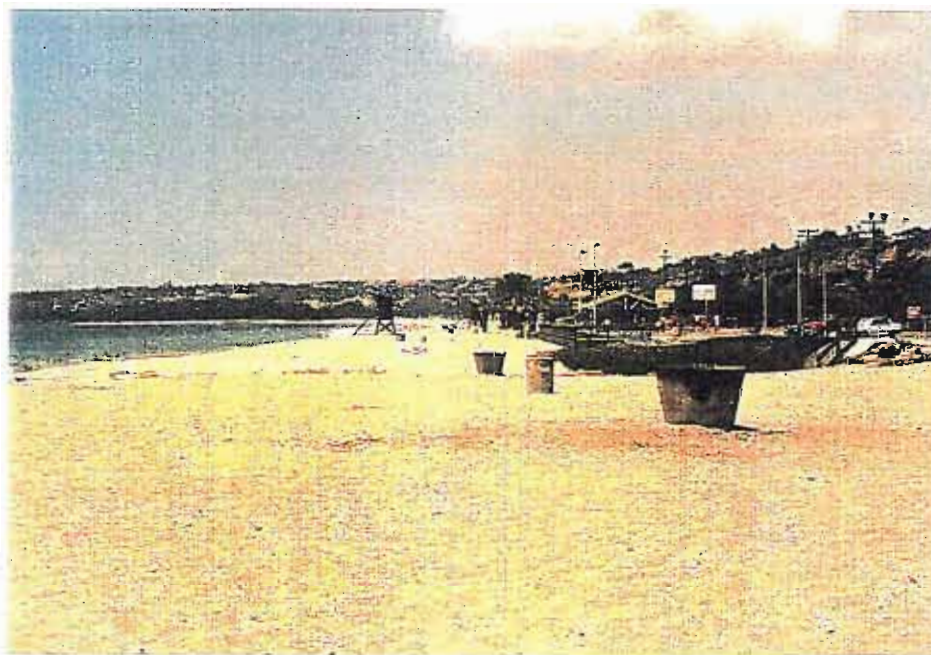
PN: 89132-2
DATE: 6/29/90
FIG. NO: 2

Figure 2 (Following Page): Site Conditions, Capistrano Beach/Doheny Beach Subunit

- A - Residential structures on narrow beach with steep profile; note existing inadequate timber bulkheads (Arrows), southern Capistrano Beach Private Community
- B - Wide lower-gradient beach, Capistrano Beach Park and Doheny Beach State Park to the north, existing structures in recreational zone on beach require revetment protection.

In order to minimize the erosive scour effects at the seaward toe of designed seawalls or revetments (discussed above), all protective devices constructed within the northern Capistrano Beach and Doheny Beach State Park areas (Figure 2B) should be provided with a "scour blanket", consisting of rip-rap stone placed at the seaward toe of such structures. Such a scour blanket would minimize erosion, in compliance with Section 30253 of the Coastal Act and the Capistrano Beach Local Coastal Program. Seawalls would probably not significantly exacerbate high natural run-up elevation hazards within the Doheny Beach State Park or Capistrano Beach Park areas, because the flatter beach profile here minimizes design breaker height, because existing recreational structures and facilities are set back 200 to 300 feet beyond the Mean High Water (MHW) line and FP-3 Flood Hazard (storm wave run-up limit) Line (Figure 2B), and because the inherent erosive damage from onshore protective devices stands greater chance of being quickly replenished by cross-shore transport of the large littoral sand supplies of this zone. Commensurately, preliminary run-up elevations calculated for this zone are much less than for beaches to the south (Moffatt and Nichol, 1985). Plates 1 through 3 depict offshore breakwaters and sandfills (artificial

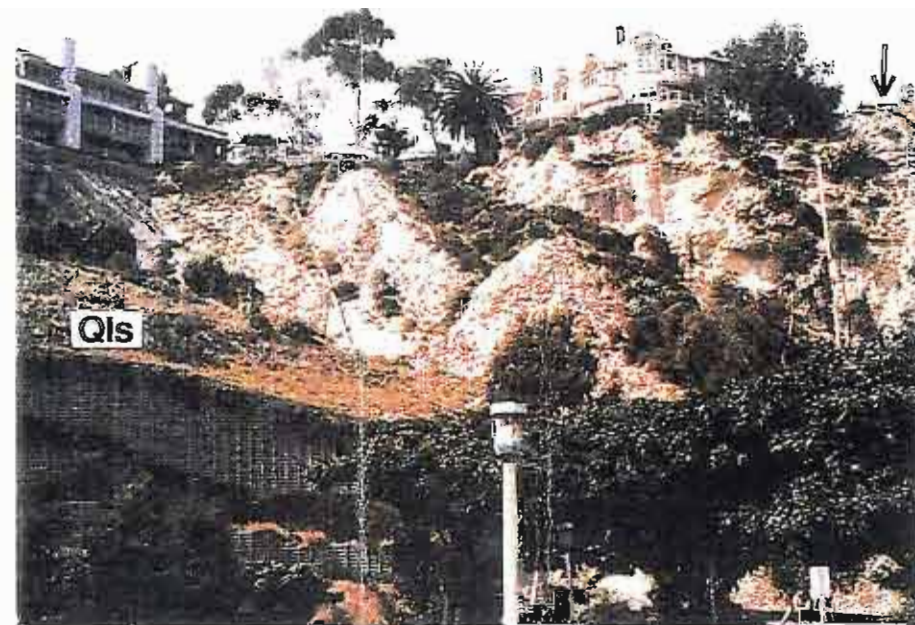
FIGURE 4
REPRESENTATIVE SITE CONDITIONS
DANA COVE AND
HARBOR SUBUNIT

Figure 4 (Following Page) - Representative Site Conditions, Dana Cove and Harbor Subunit

- A - Erosional re-entrant (arrow) with storm drain outfall and recent blockfalls; talus cone at toe of adjacent (inactive) seacliff provides partial bluff face stabilization, if adequate surface and groundwater drainage is maintained.
- B - Stabilized Cannons Restaurant slope failure (1980), with crib wall and retaining wall/rock anchor elements. Subaerial erosion continues to cause bluff retreat, particularly in zone of poorly consolidated terrace sands below high-density residential structure near blufftop at right. (arrow)
- C - Incipient slope failures, groundwater seepage problems and erosion along poorly-constructed fill slope below Cove Road near Marine Studies Institute. AF = artificial fill, TSO = San Onofre Breccia. Arrow points to CMP erosion-control device along contact.

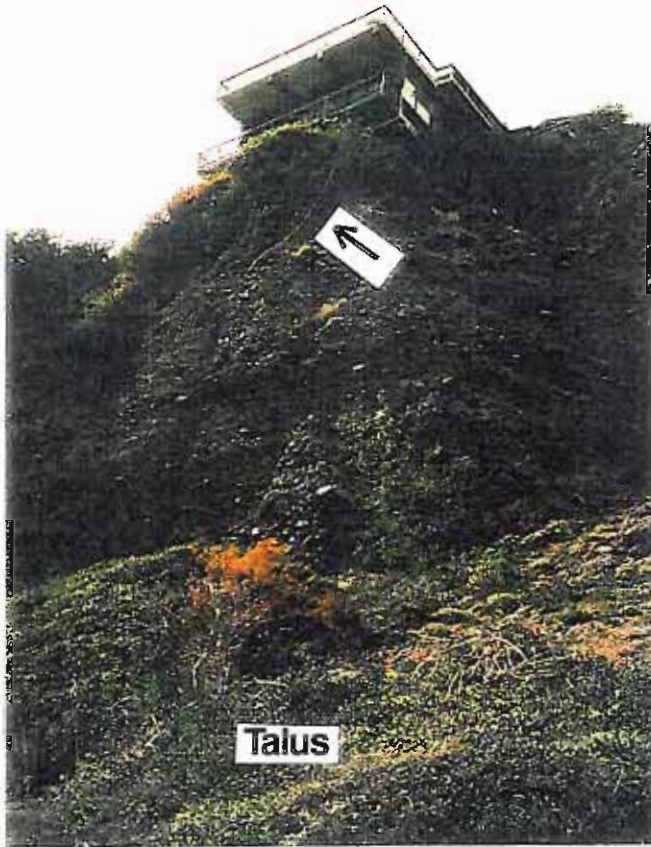
PN: 89132-2
DATE: 6/29/90
FIG. NO: 5

Figure 5 - Representative Site Conditions, Dana Point Headlands Subunit (Following Page)

- B - Low-altitude (1983) oblique airphoto of headlands; Arrow at left indicates zone of large, deep seated landslide which first failed during 1884-1891 storm period; central arrow indicates sea caves formed along prominent joint sets during 1983 storm; arrow at right indicates blockfall which failed during 1983 storm.

Note lack of sandy beach; entire headlands subject to active marine erosion.

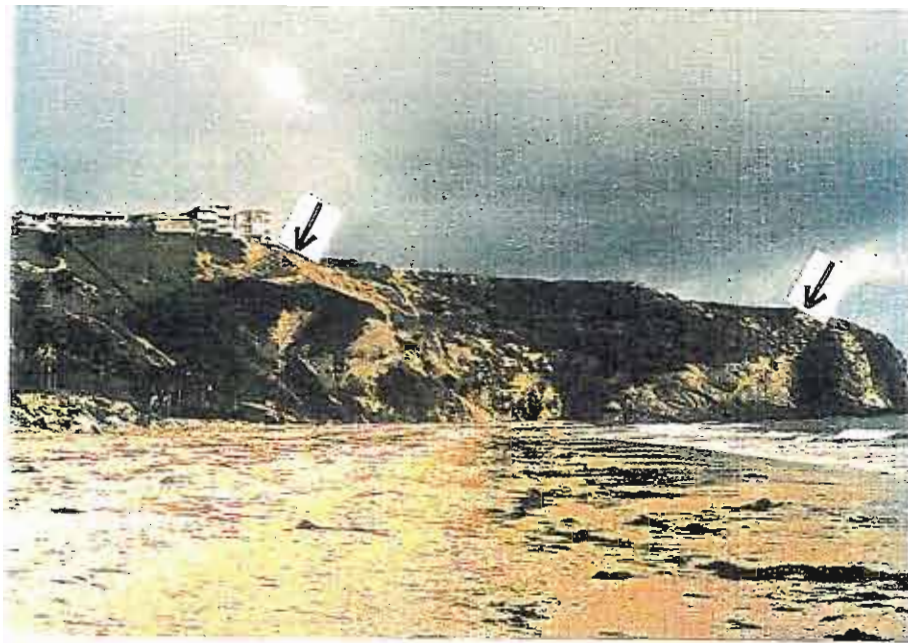
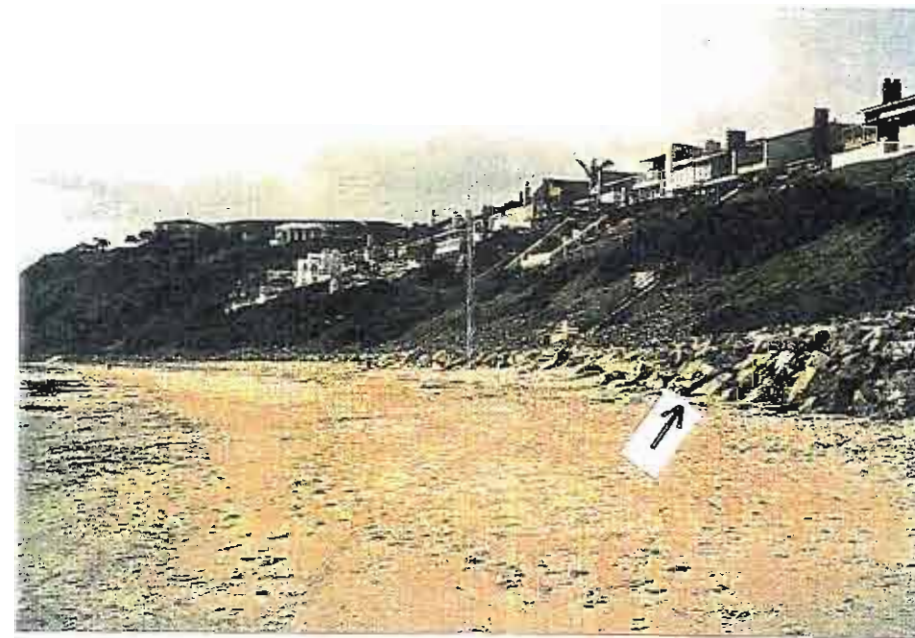
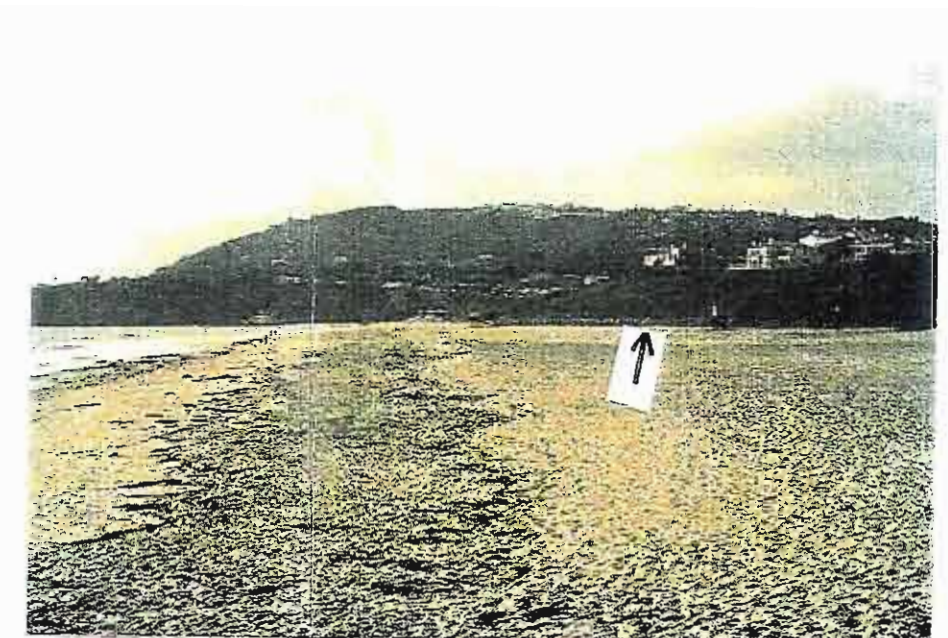
FIGURE 6
REPRESENTATIVE SITE CONDITIONS
NIGUEL SHORES SUBUNIT

Figure 6 - Representative Site Conditions, Niguel Shores Subunit (Following page)

- A - View South to south end of Dana Strand Beach; Arrow at left indicates zone of poorly consolidated, actively eroding terrace sands in graben (headscarp) zone of ancient landslide, adjacent to homes constructed at bluff edge; arrow at right indicates large bedrock landslides which failed during severe 1884-1891 storm period.
- B - View north; Damaged & partially repaired rip-rap revetment (arrow) at toe of landslide buttress fill slope, Niguel Shores (Breakers Isle) private residential community. Note width of beach.
- C - View north; Wide, low-gradient (shallow profile) sandy beach at Salt Creek Beach Park. Arrow points to rip-rap revetment, constructed at toe of landslide buttress fill for Ritz Cove residential development; revetment designed utilizing wave data from 1983 storms.

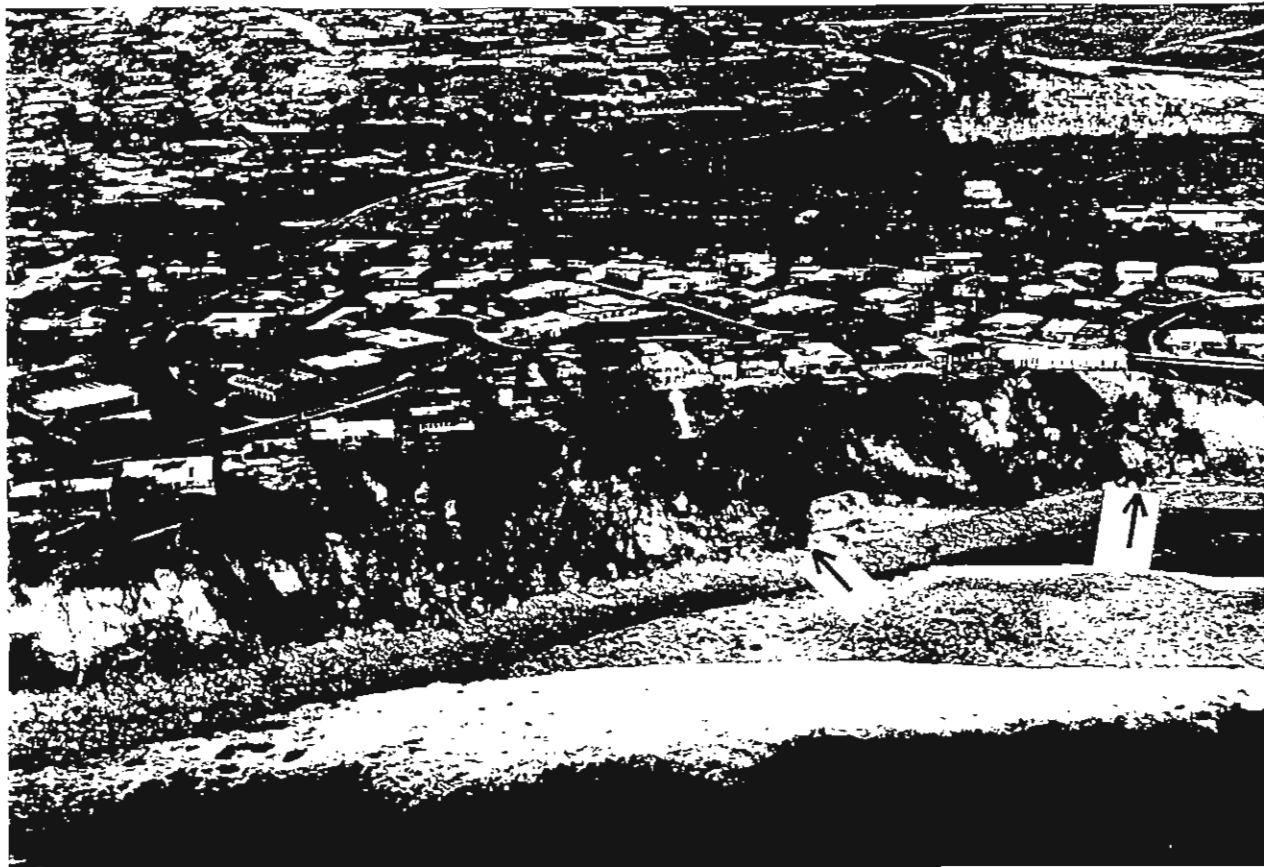
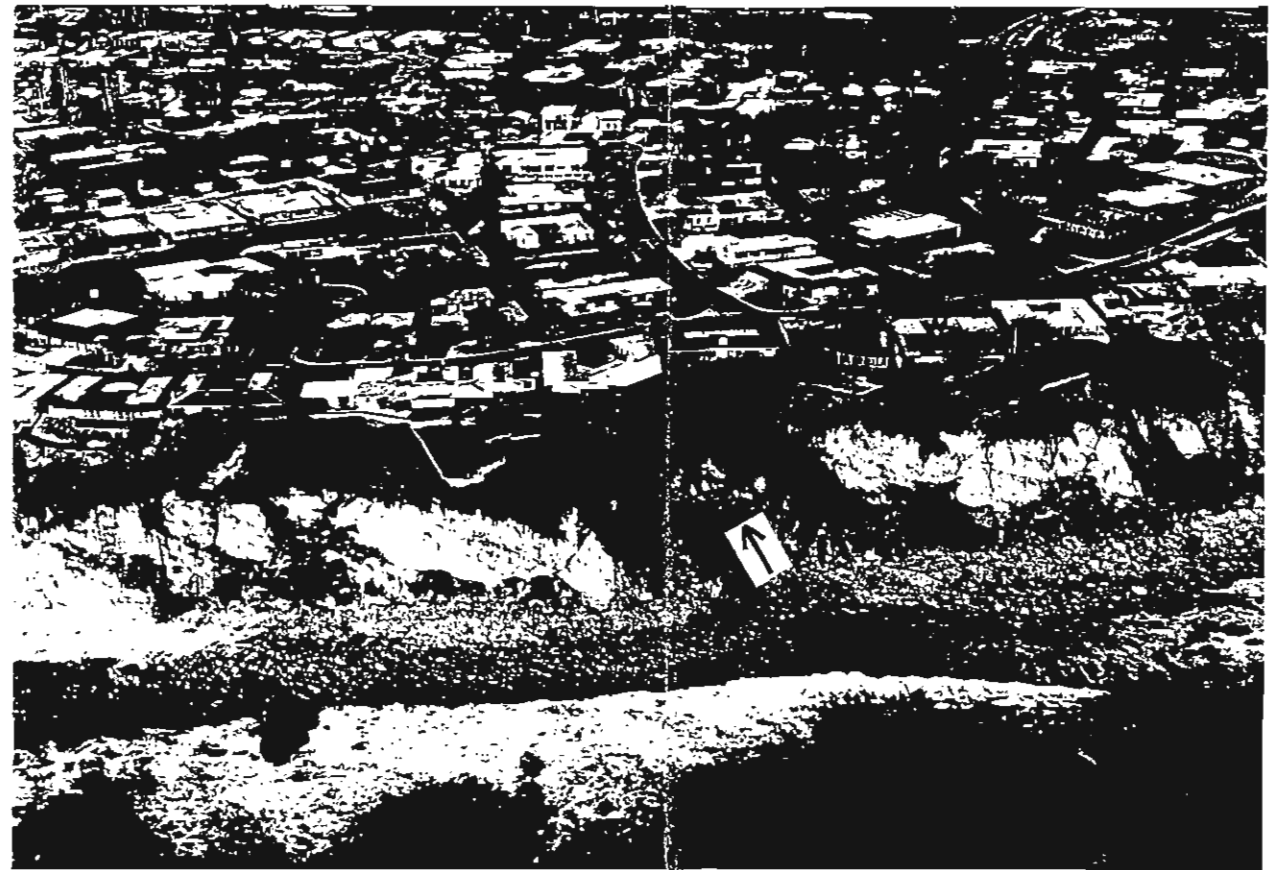
FIGURE 7
REPRESENTATIVE SITE CONDITIONS
MONARCH BAY SUBUNIT

- A - Blufftop residences along Crown Cove Road; vegetated slopes within zone subjected to historic landslides (1938 and 1969 storms) (arrows), as well as present-day erosion of blufftop terrace sands. Blufftop lot gradients slope seaward locally greater than 2%. Several structures located inside 25-foot Coastal Act setback zone (based on precise definition of bluff edge).

- B - Western end of subunit; stable seacliff exposed to active marine erosion processes (on left), adjacent to zone with historic slope failure (arrow). Lack of sand beach promotes effectiveness of active marine erosion.

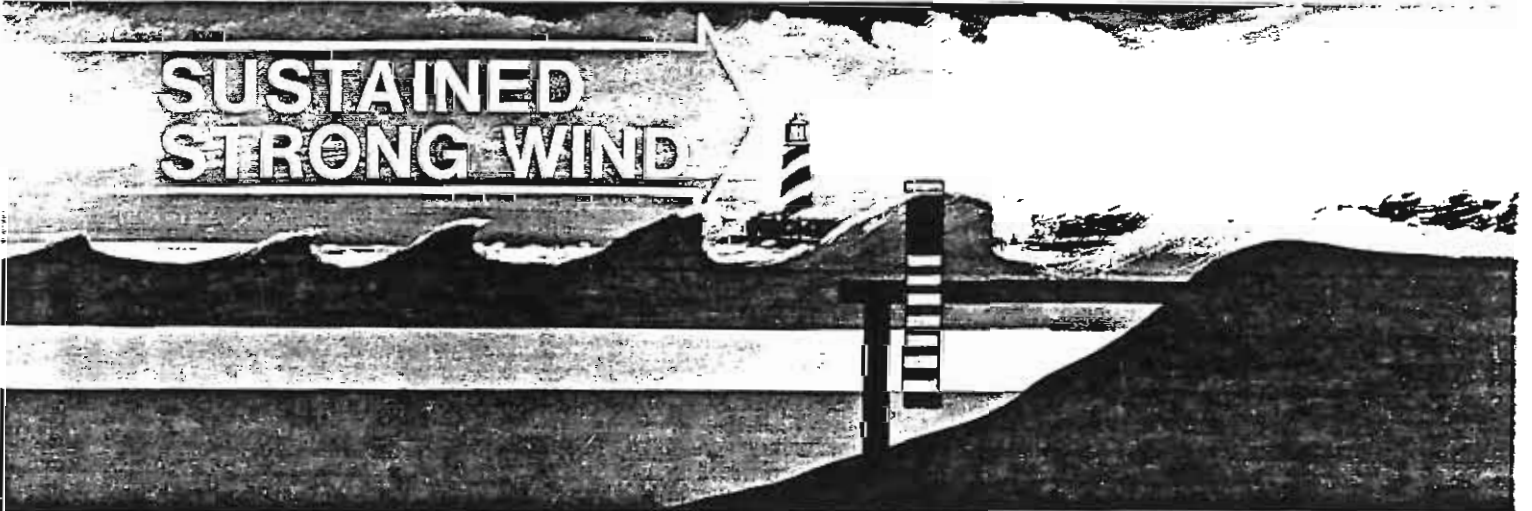
PERIGEAN SPRING TIDES MAY BE CONDUCTIVE TO COASTAL FLOODING

NORMAL TIDES

PERIGEAN
SPRING TIDE

SUSTAINED
STRONG WIND

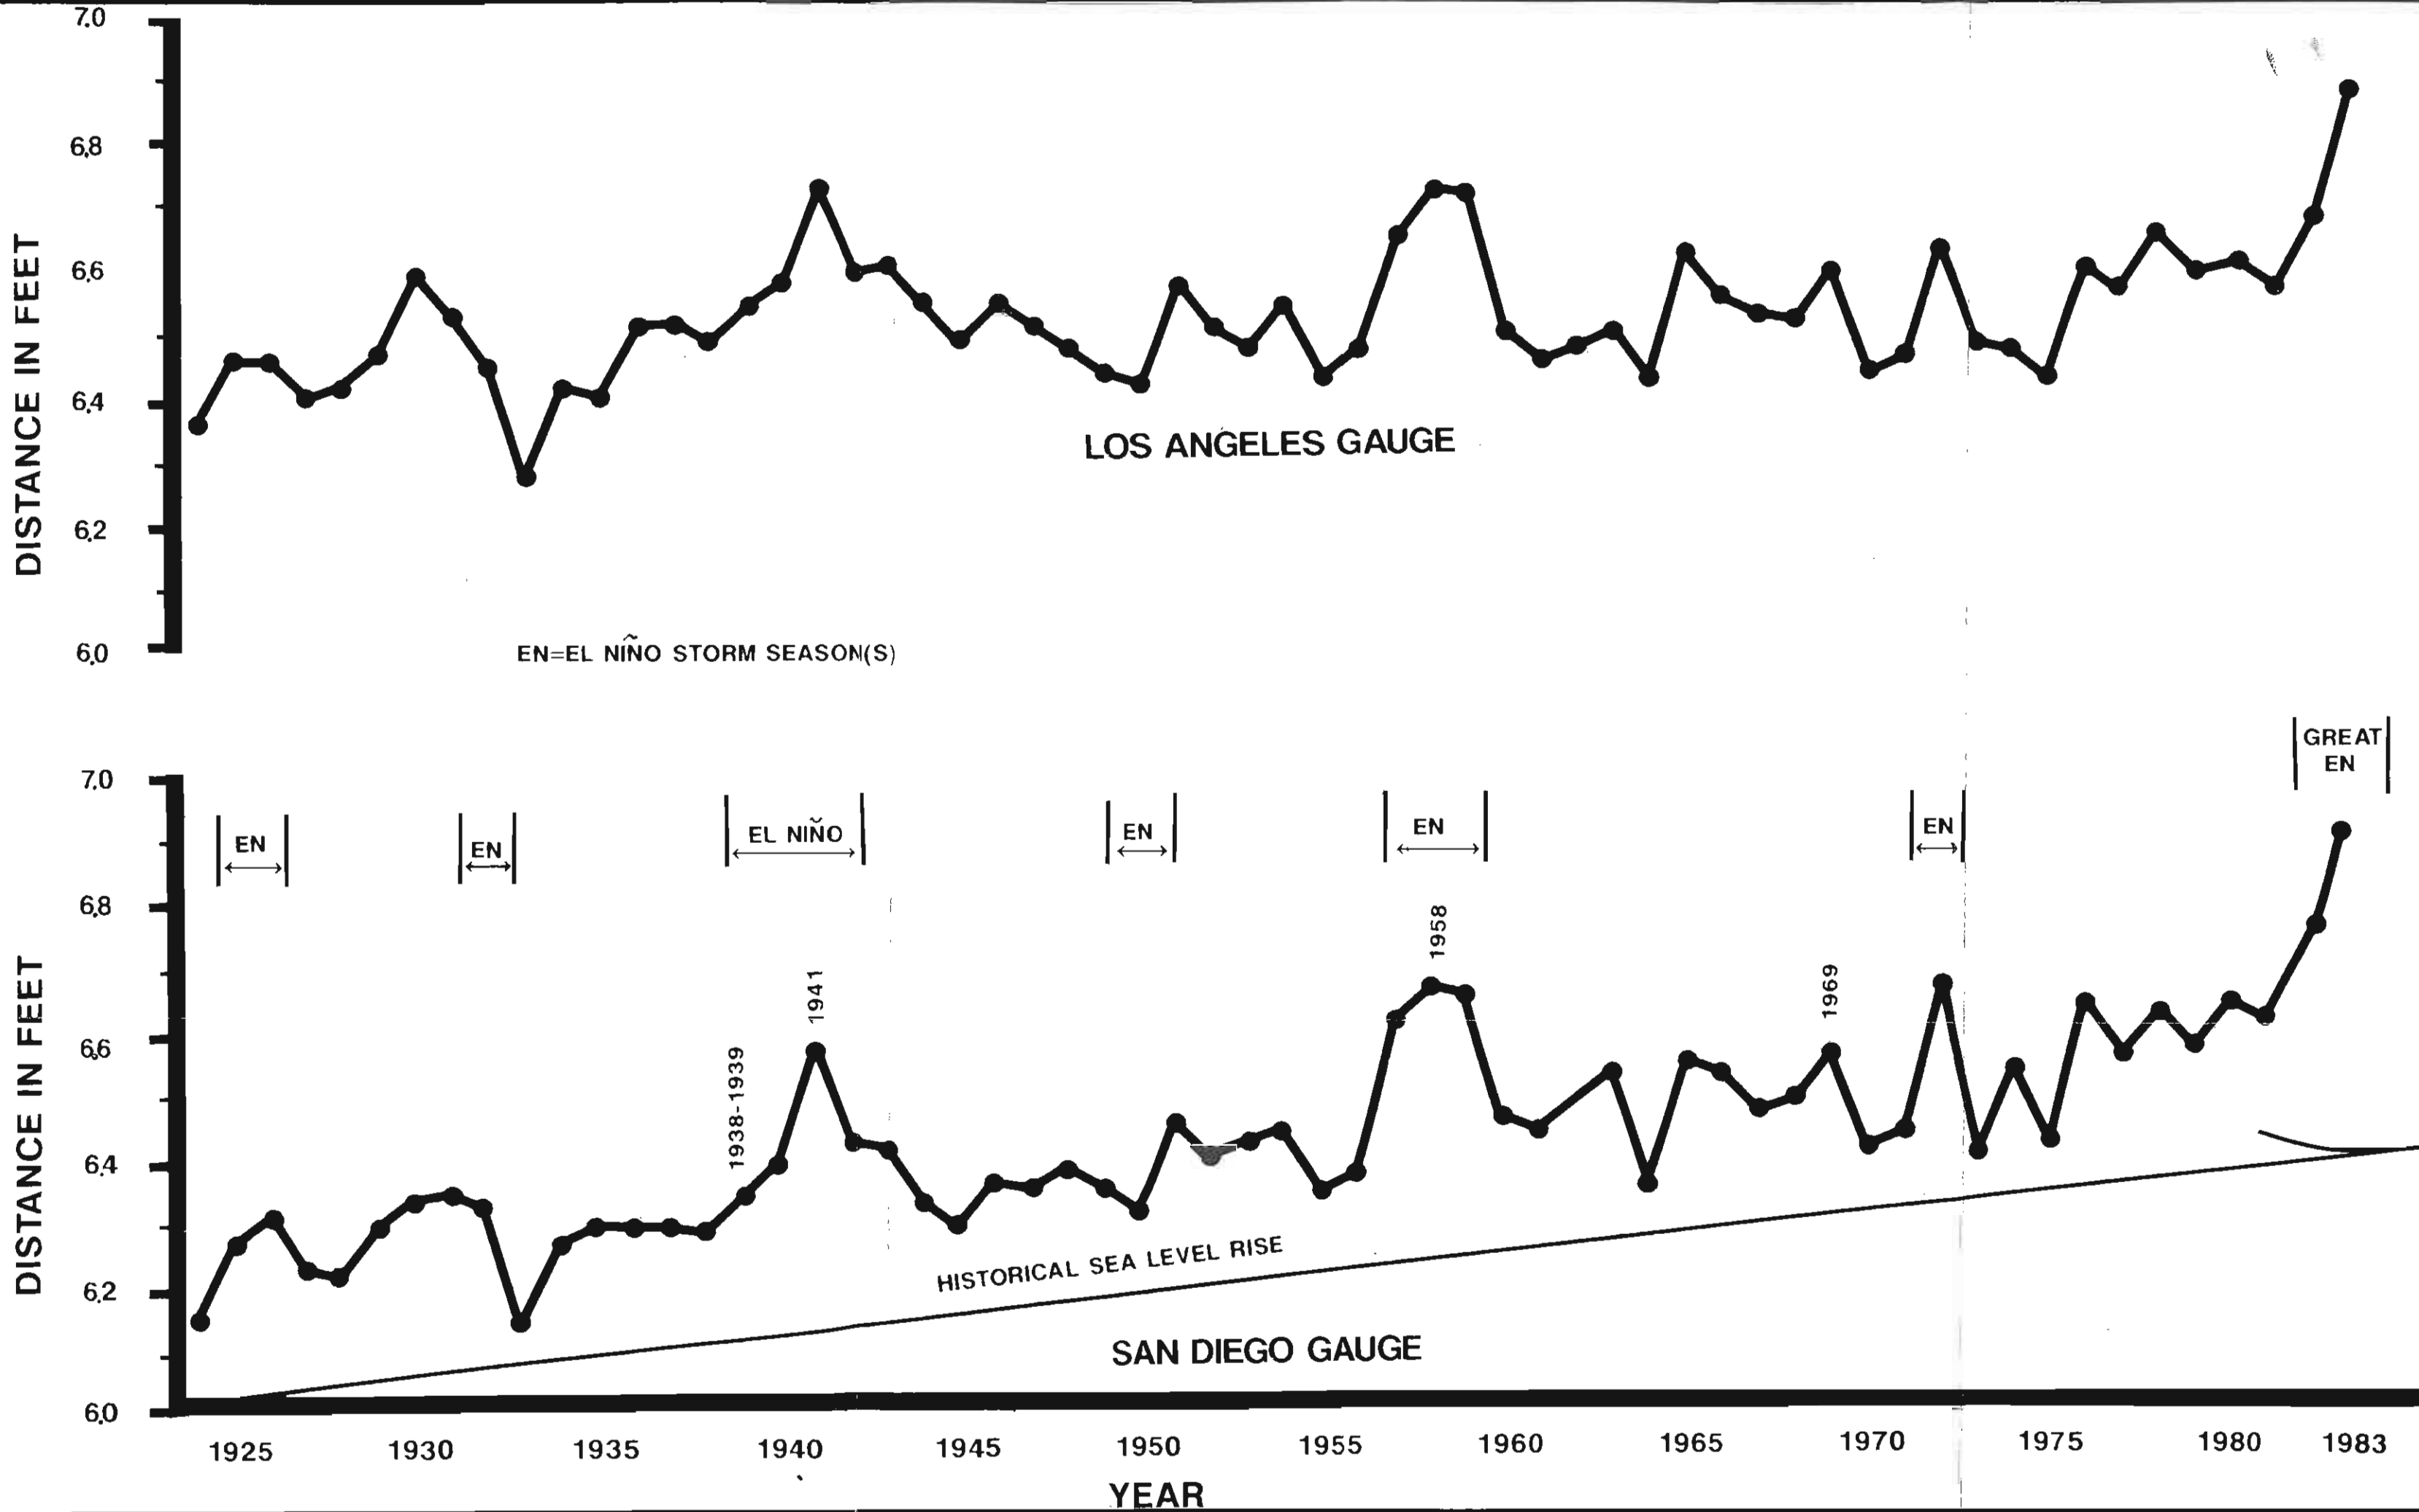
PLATE 7

ABOVE DATUM OF YEARLY MEANS
